Manhole Inspection Summary

Manhole # S150O1031MH

Insp Date: **12/2/06 8:29 AM**

Location Address: **4818 LANIER AVE**

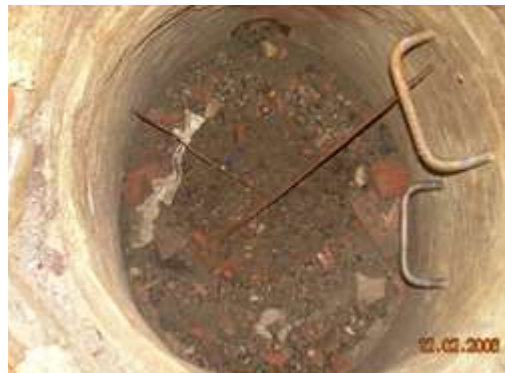
Top View

Channel debris. Corroded steps.

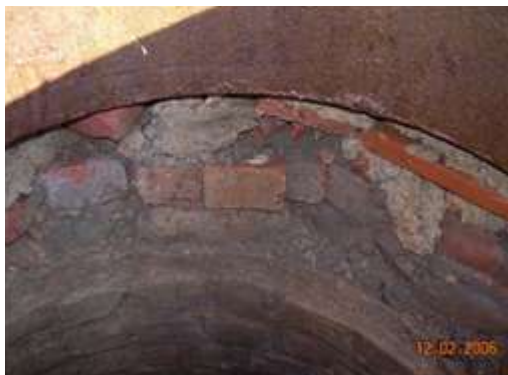
Defect

Frame leaks. Frame offset. Adjustment deterioration, loose brick, and infiltration - other side.

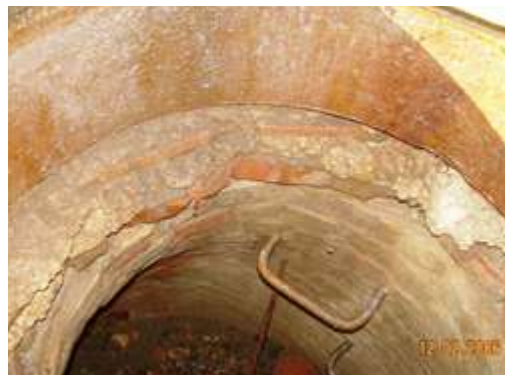
Defect

Frame leaks. Frame offset. Adjustment deterioration and infiltration.

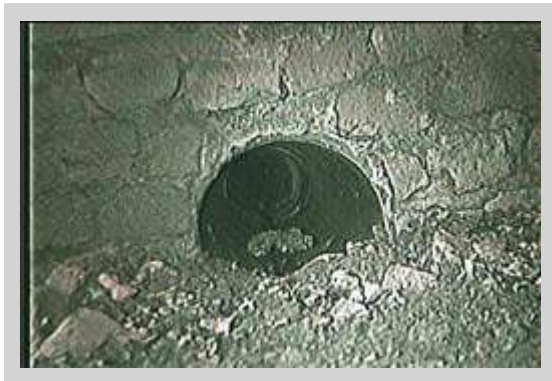
Pipe Out @ 12 O'Clock

Barrel deterioration and infiltration.
